MAJOR CZM PERMIT APPLICATION

Environmental Assessment Report

Project: VI ST ER STX(003): Storm Damage Repair to Roadways, Culverts, Embankments, Bridges, and Other Roadway Features on St. Croix, USVI

Site: Rt. 80 East Culvert

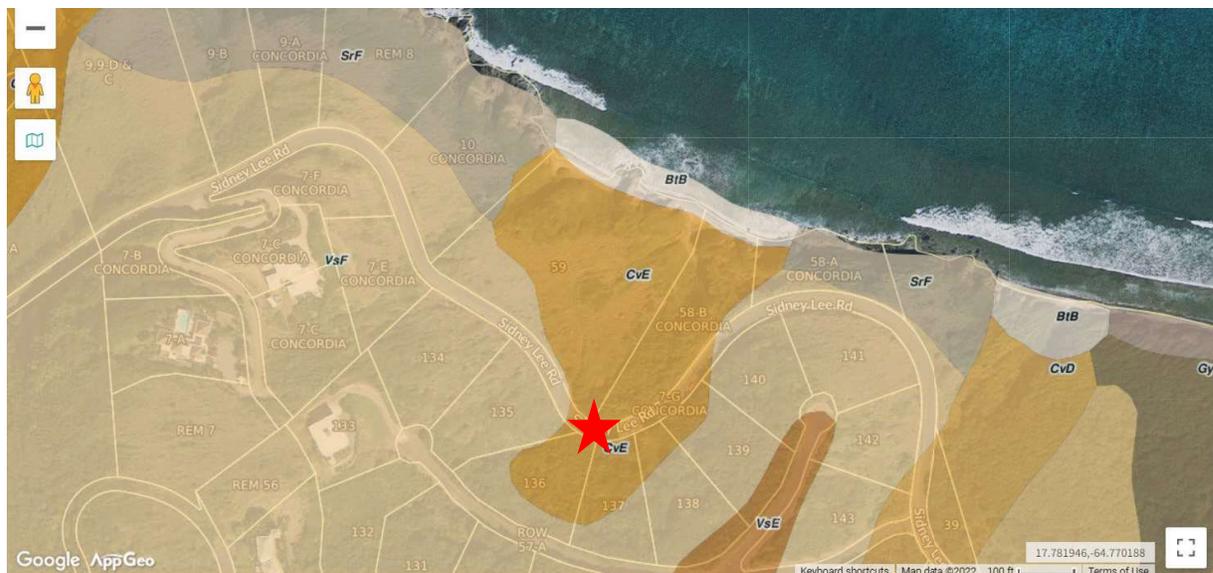
Figure 6.02.4 – MapGeo Soil Type Map

Victory-Southgate complex (VsF) with slopes of 40 to 70 percent slopes are rarely flooded. These deep, well-drained soils are made up of approximately 10 inches of loam, then another 22 inches of very gravelly loam, after which it turns to bedrock. Cramer-Victory complex (CvE) with slopes of 20 to 40 percent slopes are rarely flooded. These are also deep, well-drained soils and are made up of approximately 10 inches of gravelly clay loam, then another 10 inches of gravelly clay, after which it turns to bedrock.

The project area is limited only to CvE soils at this time. Elevation varies from 60 to approximately 70 feet above sea level.

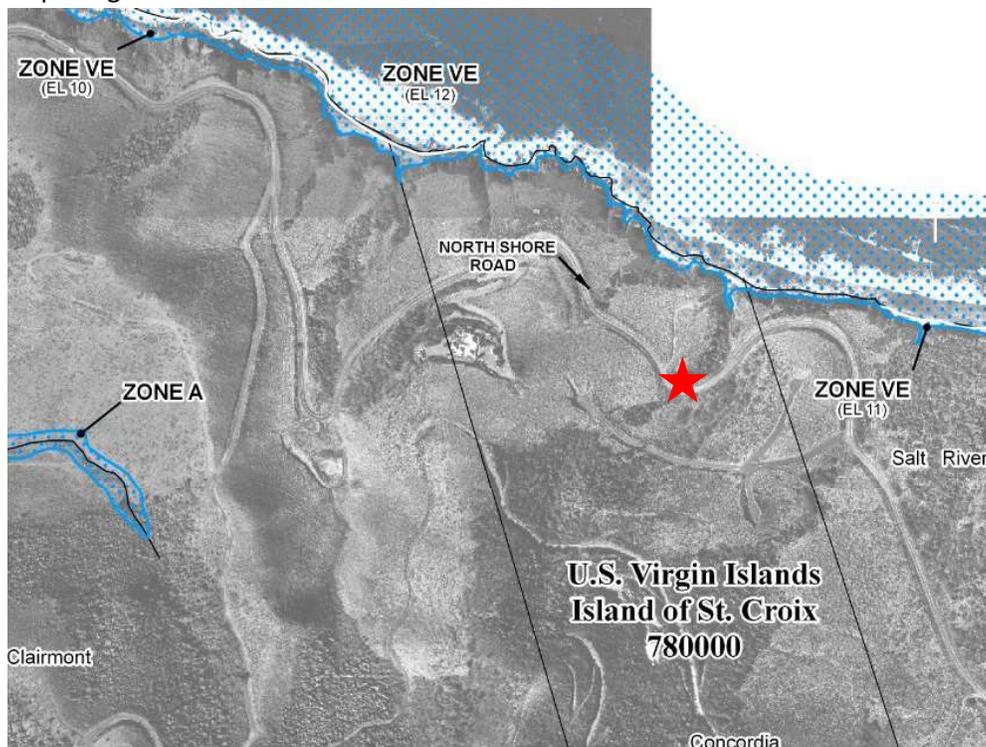
Figure 6.01.1 – Section of Flood Insurance Rate Map (FIRM) Panel 0059G, 59 of 94. April 16, 2007

Review of Federal Emergency Management Agency (FEMA) Flood Insurance Rate Maps (FIRM) for U.S. Virgin Islands Index indicate that the project area is completely outside of any flood zone. The nearby zone, immediately along the shoreline, is VE where 100yr storm elevations with velocity (wave action) have been determined to be 12 feet.

See below in Figure 6.01.1, which is a portion of FIRM Panel 0059G, increased in size, depicting exact site location relative to flood zones.
